1993 SOUTHEASTERN MT MAINTENANCE PROJECT

DSL - AMRB No. 93-M04

FINAL REPORT

SPECTRUM ENGINEERING

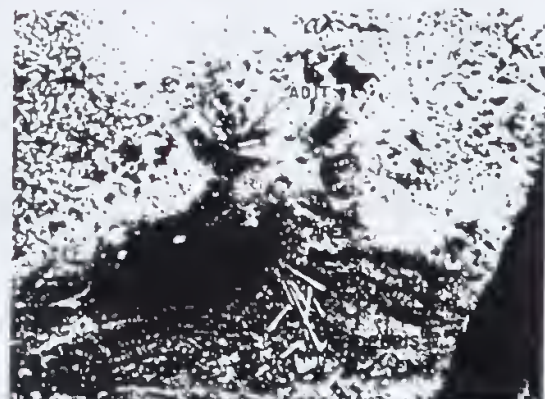
② PICTURE 2 SHOWS THE ADIT, COAL SLACK AREA, AND DEBRIS

The work is to close one adit which has reopened and reseed the prior vegetated area which has failed.

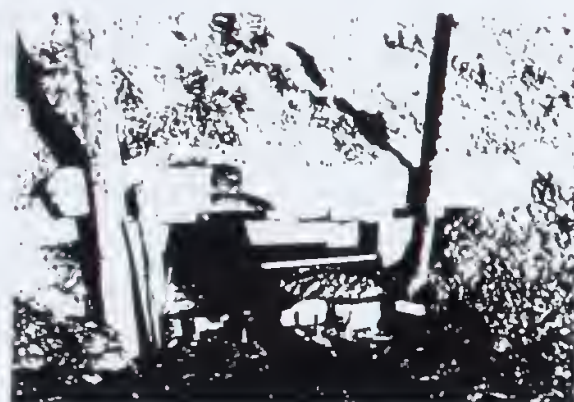
③ PICTURE 3 SHOWS THE PARTIALLY BLOCKED ADIT ENTRANCE

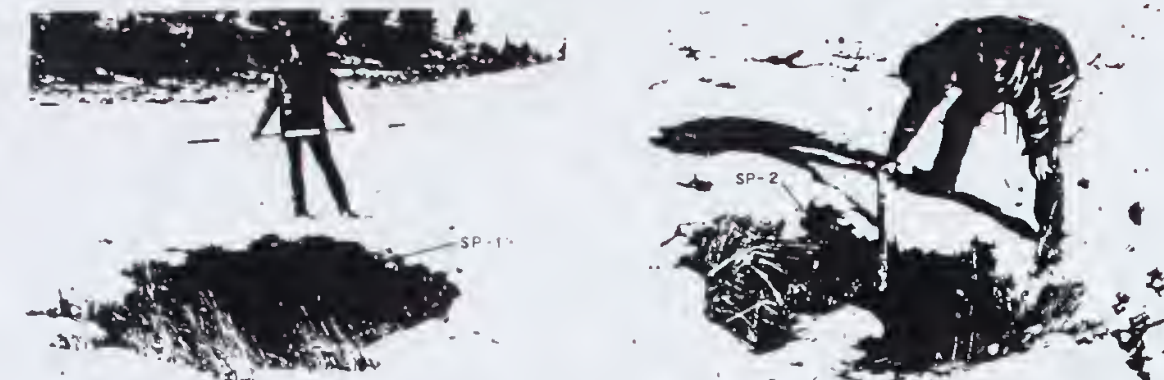
① PICTURE 1 SHOWS SUBSIOENCE PIT 1

② PICTURE 2 SHOWS SP-2

AS-BUILT
Three new subsidence holes were backfilled and revegetated.

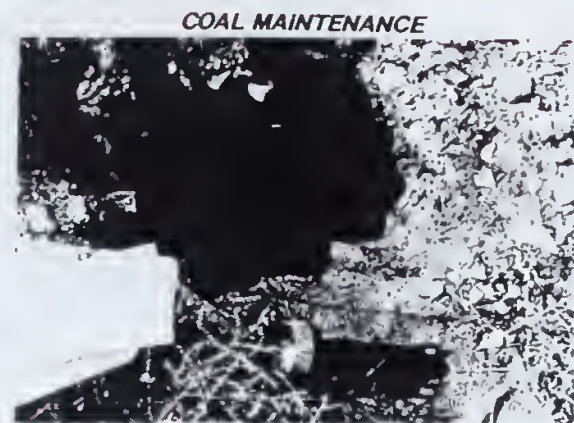
① Picture 1 is a close-up of the adit opening looking east.

1. Salvage 1' of cover soil from the borrow area (estimate 3 cubic yards).
2. Excavate adit opening to allow backfilling and stockpile material (estimate 1.5 cubic yards).
3. Backfill adit with borrow material and stockpiled material from excavation of adit opening (estimate 5 cubic yards plus 1.5 cubic yards from excavation step).
4. Place 1' of cover soil over backfilled subsidence and sealed adit.
5. Fertilize, seed and mulch all disturbed areas (estimate 0.01 acres).
